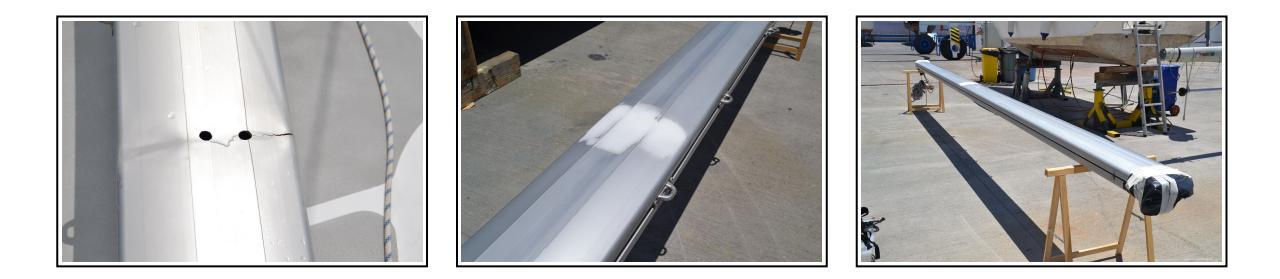
The main sheet on Bird of Passage is attached to the middle of the boom, a practical solution in many respects but not ideal in a violent gybe. When the boom is thrown from one side of the boat to the other without control the sudden stop when the main sheet is stretched creates forces that can bend the boom sideways more than it can resist.

On the left picture above you see how bad the damage was. We were lucky that the boom did not break in two. That could have created a much worse situation. The other side of the boom was more deeply buckled than the side shown on the picture. For this reason I drilled the two holes that you see and through them I knocked out the indentations from the inside. This was a must to make the single line reef system inside the boom work correctly. After that I added epoxi filler to fair the surface.
