The Launch

by Johan Kjellander 2009, 2014

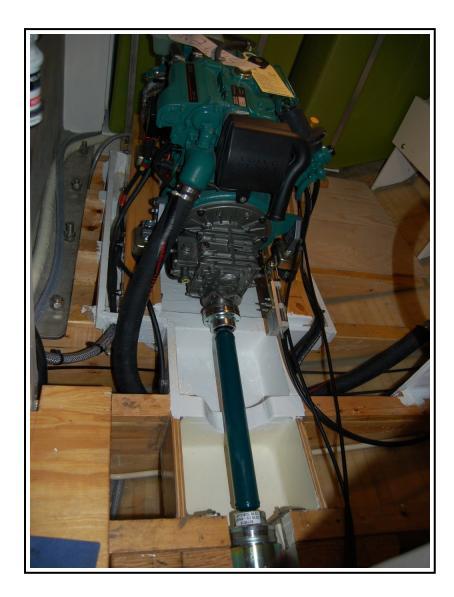
Motor installation is now more or less finished. Here is a picture of Sixten (the starboard motor) with control cables for speed and gearbox (dual station), exhaust, cooling, fuel, 12V etc. attached. Most of the equipment that I bought fitted well, but some of the things did not. Dual station system for two motors shouldn't be uncommon, but so it seems. The speed control on the Volvo's were made for single station and the Morse dual station stuff I bought didn't fit the Volvo. So, two days of welding, grinding, testing etc. and then everything was all right. I wonder how many times I have bought things that don't fit. Somebody is making a lot of money on us backyard builders !

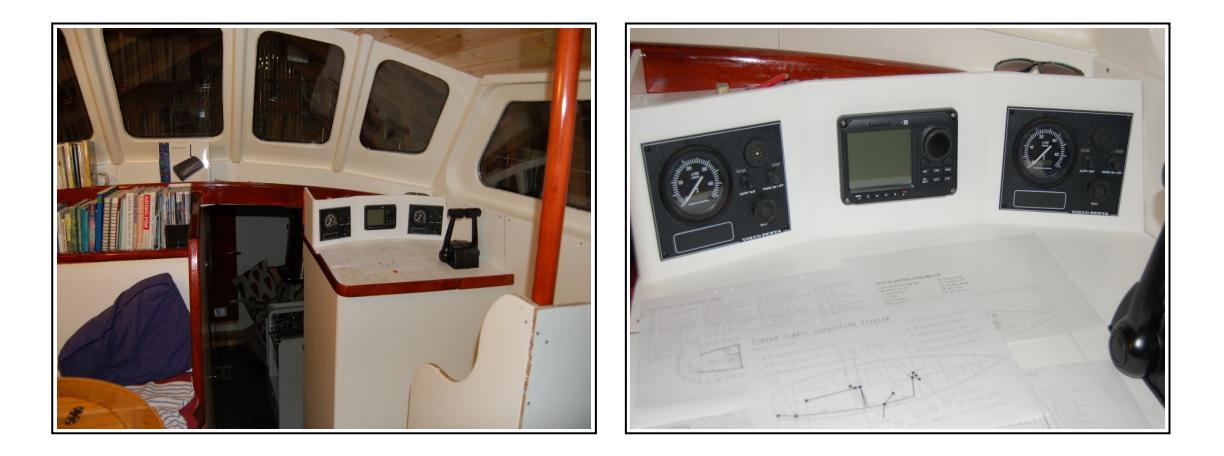
The navigation table is now finished. Two Volvo control panels and in the middle the Simrad AP28. I chose Simrad because they seem to be making equipment that fits bigger boats better. For one thing, they have the biggest hydraulic pump available. Many commersial vessels have Simrad systems.

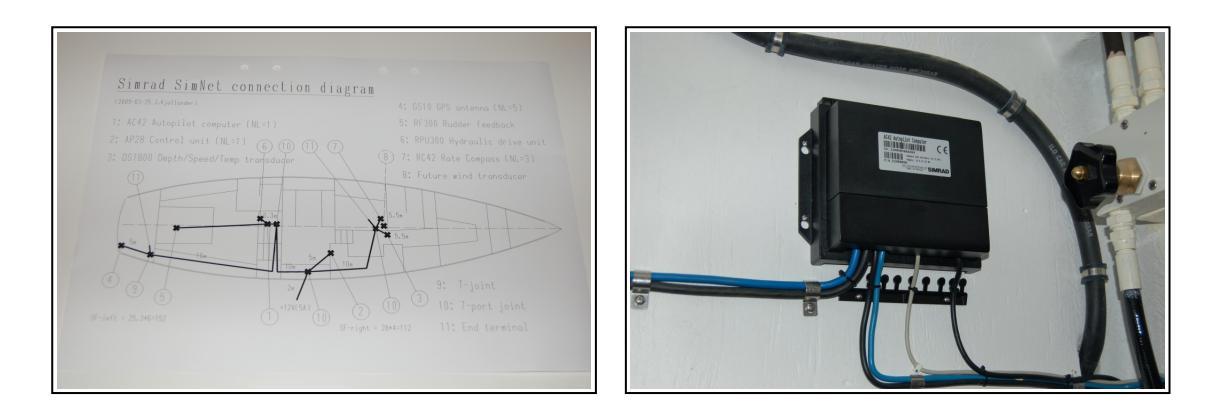
Above is a connection diagram showing the entire system. It includes the AP28 auto pilot and its computer, the AC42 to the right, mounted in the engine room.

The AC42 can regulate up to 30 Amps of current to the hydrualic pump motor. The Simrad system is connected through a CAN bus system called SimNet and it talks NMEA 2000. This means that you can connect many things from different suppliers. The speed sensor to the left, also includes a depth sensor and a water temperature sensor. In the middle is the rategyro compass and to the right is the GPS reciever. Things that will be added in the future are wind data and a second AP28 or AP24 outside. The Simrad stuff is expensive so some things will have to wait.

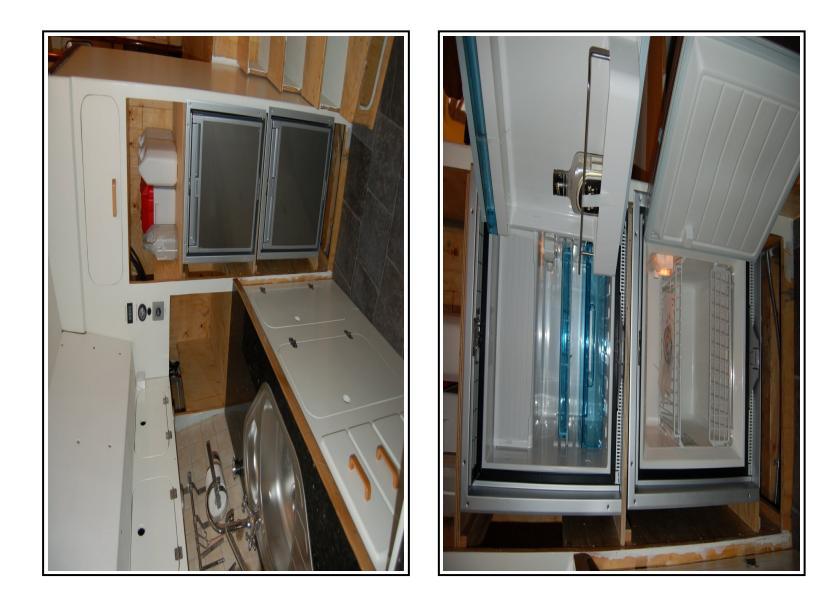
If everything works out as planned we may be able to take a trip with Bird of Passage this summer, without the rig though. If so, we will need a working galley and for that reason we have now installed a fridge and a freezer. They are two separate units. The idea is that the freezer can be turned off when not needed to save energy but turned on again when the god of fishing is smiling at us. 50 litres of freezer and 65 litres of fridge. The fridge, btw also includes a small freezing compartment so that you can make ice for your drinks without having the big freezer turned on.

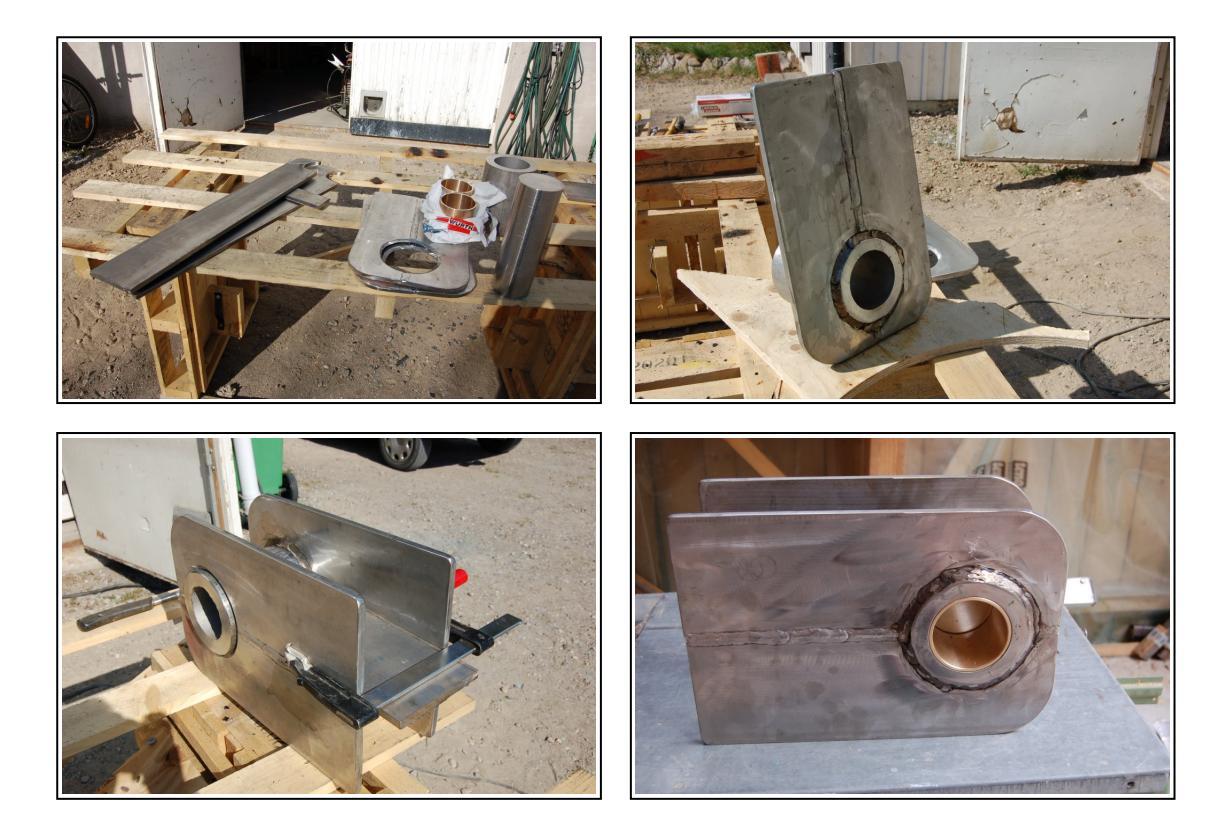
Launching is close now, one or two months left. Only one big job to do and that's the retractable ballast keel. Four tons of lead inside a stainless sheet metal mold with a strong internal structure also in stainless steel to keep everything together. Together with the keelbox the total weight of the ballast (fixed and retractable) is around 5.5 tons which is 40% of the boats displacement. Quite a lot of ballast for a modern boat. On the other hand she will be stable and sail well with moderate heeling. The calculated rightening moment RM is 113 kNM at 30 degrees of heeling which is relatively much for a boat with a design displacement of only 13.6 tons. Above are some of the parts that will make up the retractable keel structure. The diameter of the keel pivot is 90 mm.

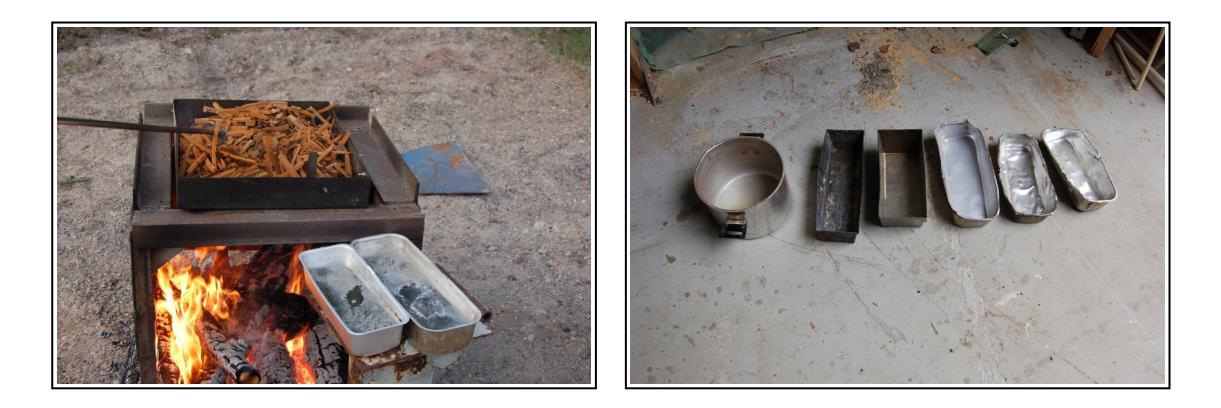
I have been collecting scrap lead for many years now and some of it is car wheel balance weights. These need to be melted and cleaned from steel clips before they can be used. For that purpose we built this primitive furnace heated by a wood fire. To form lead bars you need some kind of molds, aluminum boxes work but steel is better.

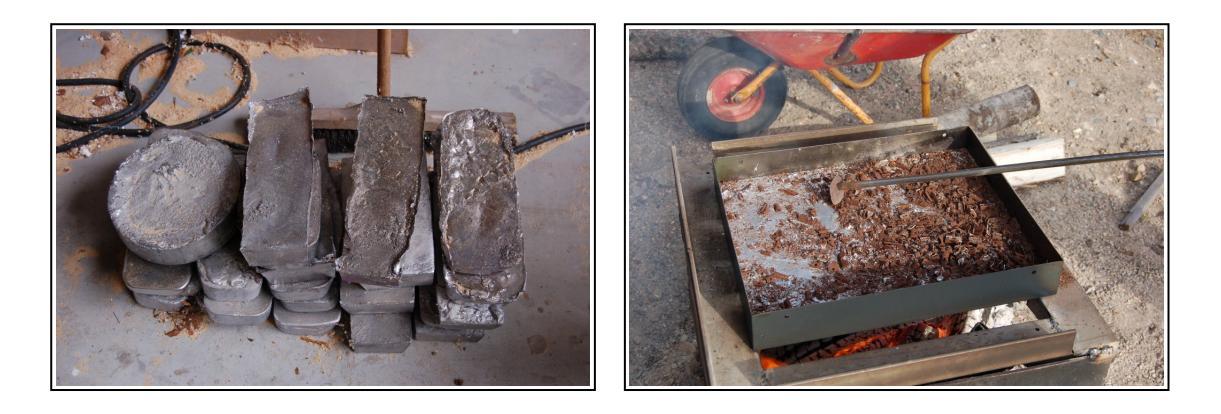
Here is the result, 300 kg's of lead bars. The only thing left are the steel clips. You can see more pictures from the lead melting <u>here</u>. To melt all the 4 tons of lead for the keel a larger furnace is needed so we have now built this monster that we hope will be able to melt at least one ton of lead at the time. We will probably try it out with some larger pieces of scrap lead later today.

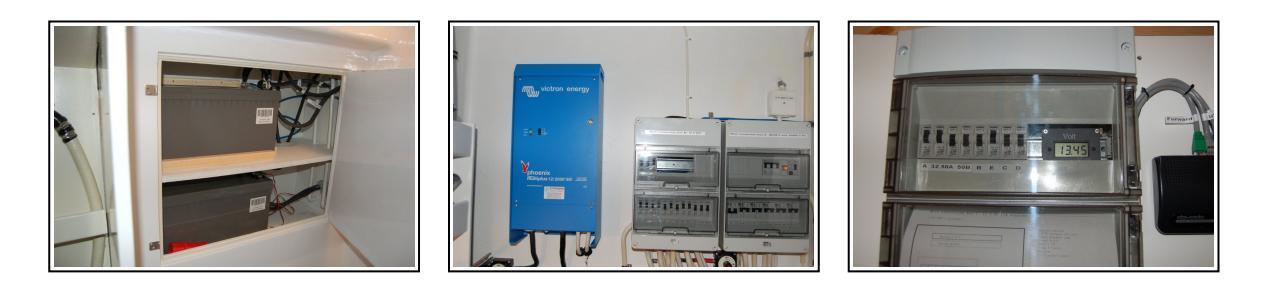
The electric system is now more or less finished. Latest additions are two 200 Ah AGM batteries and a Victron charger/inverter. To keep an eye on the voltage I bought a relatively sensitive voltage sensor with digital display and

mounted it in the deck house where it is easy see. Next year I will add solar panels to the system.

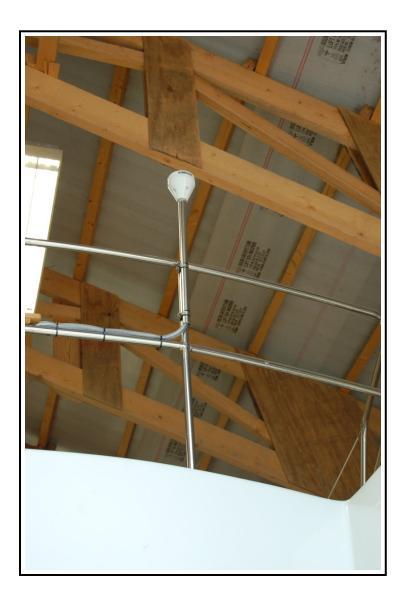
A final picture shows the GPS sensor mounted on the pulpit. This is a temporary solution for this summer. I want to be able to test the Simrad navigation system with the GPS connected. Next year I plan to build some kind of mast for all antennas (GPS, AIS, NAVTEX, TV, GSM/UMTS etc.) and a future radar as well.

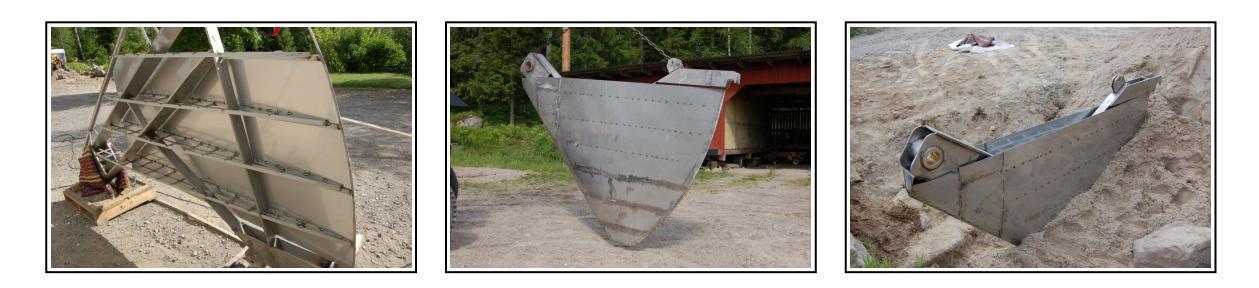
After that I covered the structure with 2 mm stainless sheet metal. All metal is 316L or EN 1.4404 with 2% molybdene. Expensive, yes but more resistant. Then down into the ground stuffed with fine sand all around.

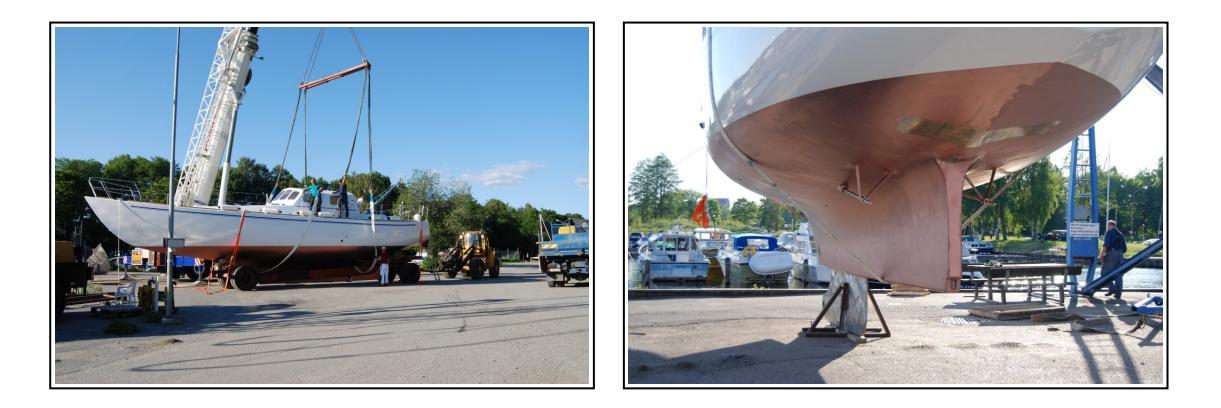
The boat was lifted and then lowered over the keel which was fixed in an upright position by a temporary support made from scrap metal.

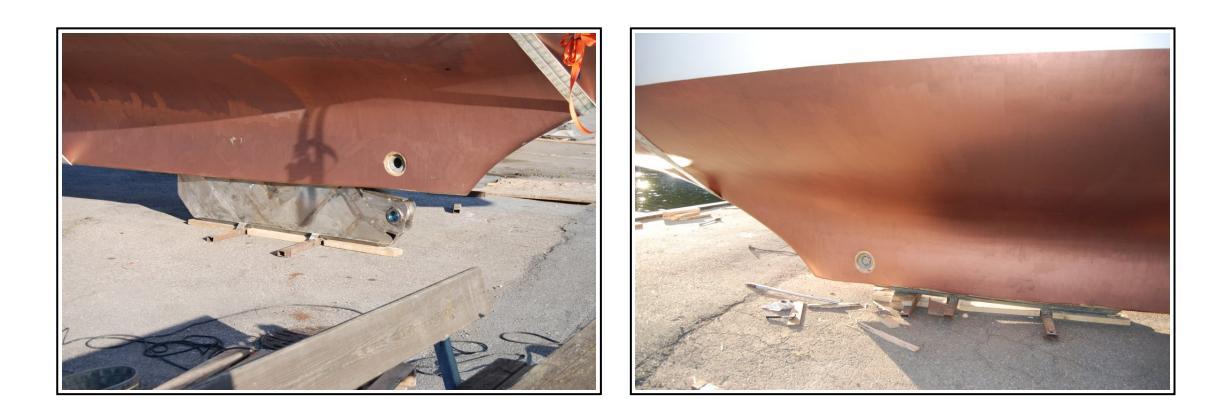
Half way down the metal support was removed and the boat could be lowered to a position so that the keel bolt could be mounted.

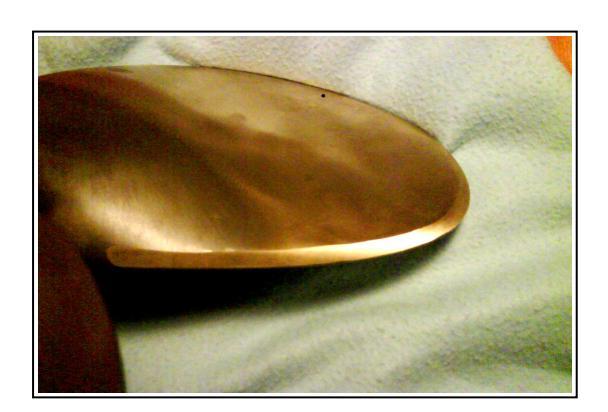
After some investigation I got in contact with one of the few persons in Sweden who has the right tools and the right knowledge to fix a propeller, a "Propeller doctor". First he grinded the trailing edge of the blades to get rid of the singing, a so called "anti singing chamfer". If you read the JulySeptember blog below, you will see that I did a similar job under water with a metal file this summer, but the propeller doctor had an air driven grinder and was not disturbed by heavy diving equipment so I'm sure he made a much better job.

By the end of October the big mobile crane came to the harbor to lift some boats for the winter. We then took the opportunity to also lift Bird of Passage, remove the propellers and launch her back into the water again without propellers. The propellers needed adjustments to cope with terrible singing and wrong pitch. Even if Bird of Passage stayed in the water she would not need any propellers during the winter since the plan is to stay in the harbour and use the boat only for living. Leaving the boat in the water makes life aboard more comfortable in several ways. Even if there is ice, there is always water under the ice and the water temperature is usually higher than the temperature of the air. This saves energy (money). With the boat in the water, boarding is easy, you don't need to climb a ladder. Finally, getting rid of gray water is easier with the boat in the water than on land.

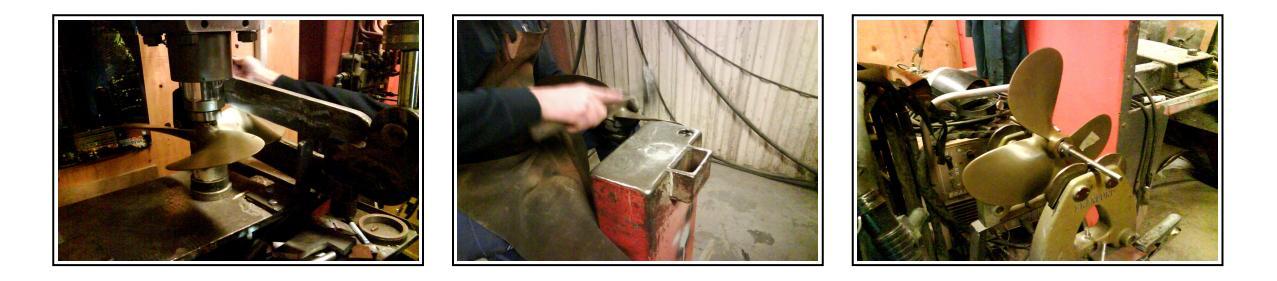
Then he put each propeller in a specially designed self made "hydraulic pitch adjuster". With this machine he twisted the blades so that the pitch was increased by one inch. Finally he did what is usually called "cupping". This means that he manually bent the trailing edge of the blades by hammering. A job for a real expert. Cupping increases pitch but also reduces singing. After this he tested the propellers for static balance. The final effect is that I now have two propellers with 1.5 inch more pitch and hopefully without singing. A friend of mine who is a very good diver was going to re-mount the propellers a few weeks ago but then the real winter came with 15-20 degrees below zero and thick ice. That job will have to wait.
